Manhole Inspection Summary

Manhole # S35M__032MH

Insp Date: **3/25/08 10:01 AM**

Location Address: **601 light st**

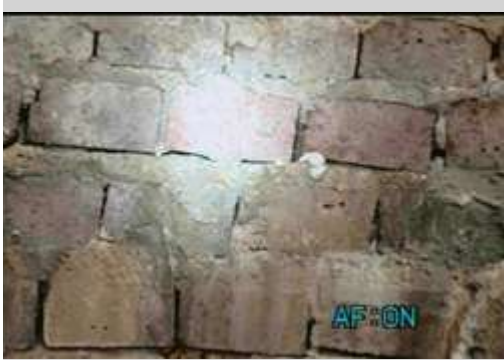
Defect 4

Condition: ☐ Sound ☐ Cracked ☐ Root Intrusion ☒ **Loose Brick** ☐ Deteriorated

Infiltration: ☐ None ☐ Joint ☐ Cracks ☒ **Mortar** ☐ Roots ☐ Wall

more missing mortar in corbel

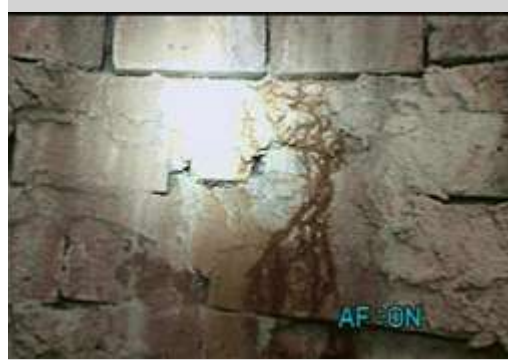
Defect 3

lose bricks in corbel, signs of infiltration

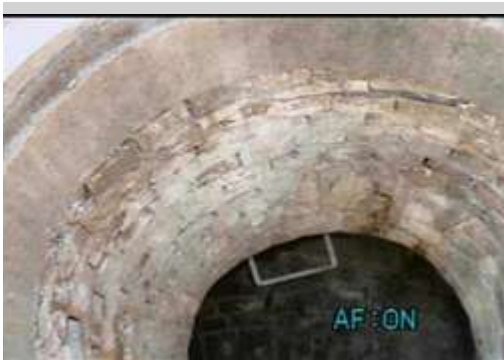
Defect 2

Steps Count: **3** Missing: **2** ☒ **Corroded**

steps

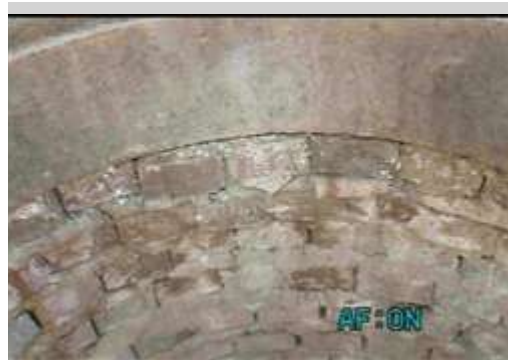
Defect 1

Condition: ☐ Sound ☐ Cracked ☐ Root Intrusion ☐ Loose Brick ☒ **Deteriorated**

Infiltration: ☐ None ☐ Joint ☐ Cracks ☒ **Mortar** ☐ Roots ☐ Wall

mortar missing in chimney and signs of infiltration

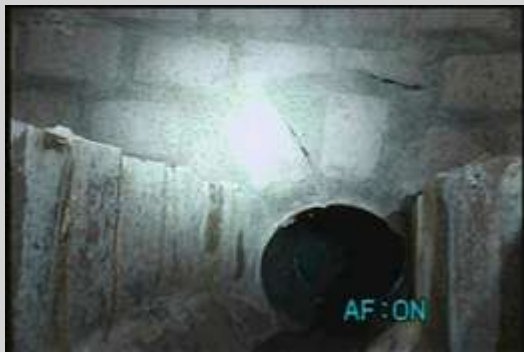
12 O'Clock Outflow

6 in. Circular Gravity Sewer
Pipe Out @ 12 O'Clock

Pipe Material: **Clay** ☐ Pipe Lined

Invert Depth: 7.00 (ft.) Flow Characteristics: **Slow**

Infiltration: **None** Pipe Seal Cond: **Unknown**

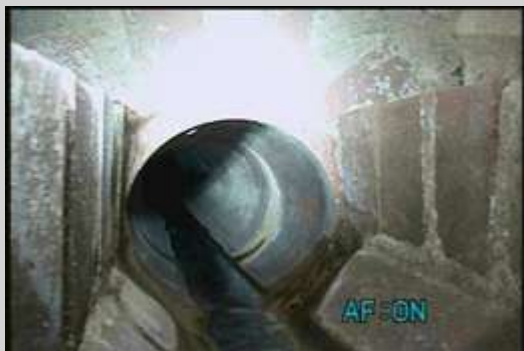
5 O'Clock Inflow

6 in. Circular Gravity Sewer
Pipe In @ 5 O'Clock

Pipe Material: **Clay** ☐ Pipe Lined

Invert Depth: 6.96 (ft.) Flow Characteristics: **Slow**

Infiltration: **None** Pipe Seal Cond: **Unknown**
